Project: 19047- Technical Note 3	27 August 2019
Baydon Church – St Nicholas Defects to the Chancel and Vestry stone walls	
Client : Baydon Church LPPC / Whitton Parish PPC	
Revision History: First issue

## 1. Objective of this note

To provide background and history of inspections and a record of the defects as noted to date to the stone walls.

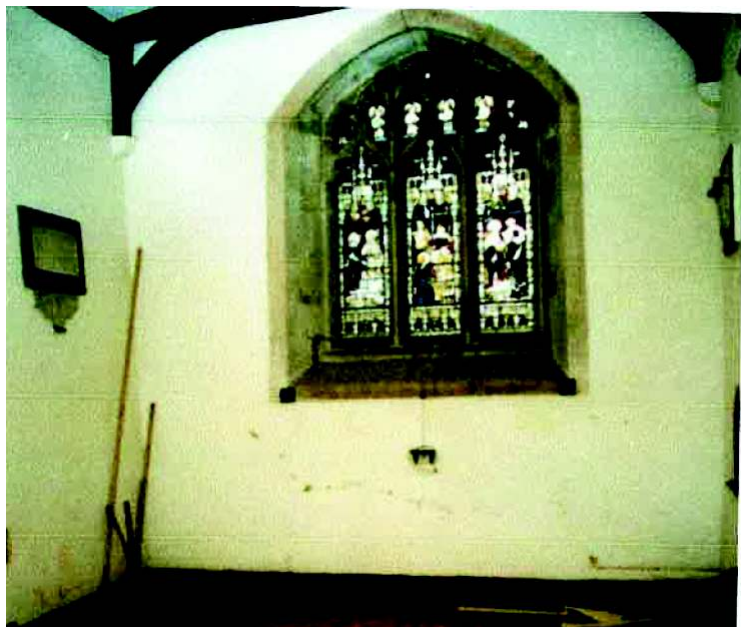
**Figure 4.1-** earliest photo known from 1991 when the underfloor heating was installed to the chancel area and no record or sight of the in the photo known. From the photo repairs to the mortar in the stone work over the east window key stone might be made out but this is not proven.

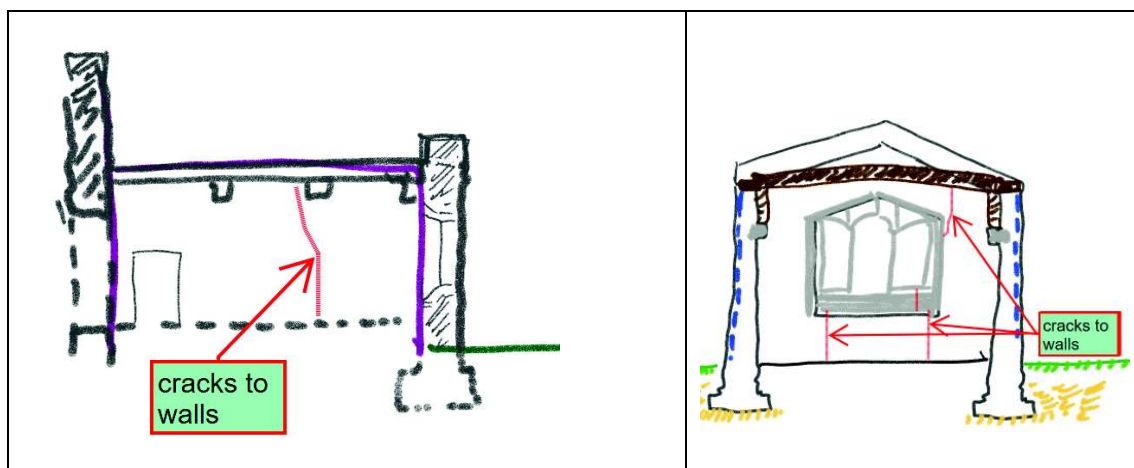
**Figure 4.2** diagrammatic view of the location of the vertical cracking to the internal walls known to be in place in 2013.

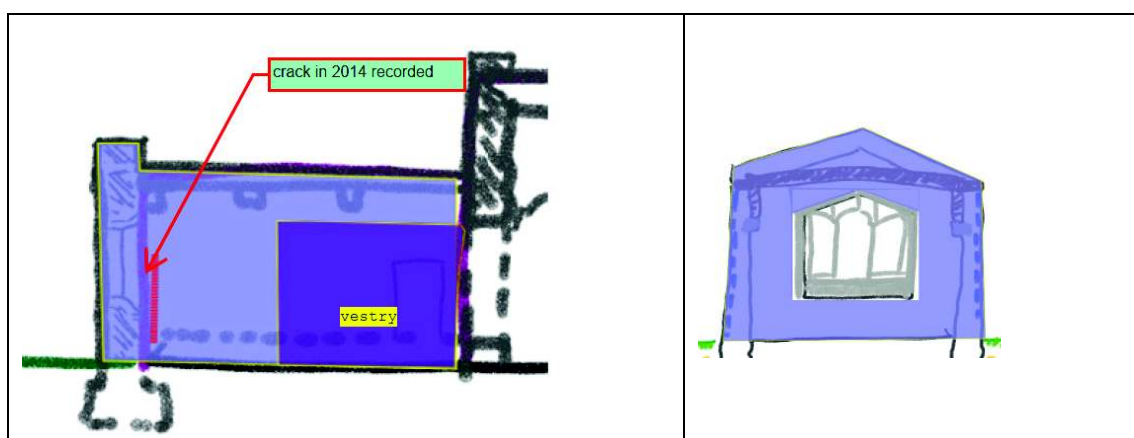
**Figure 4.3** diagrammatic view of the location of the vertical cracking to the external known to be in place in 2013.

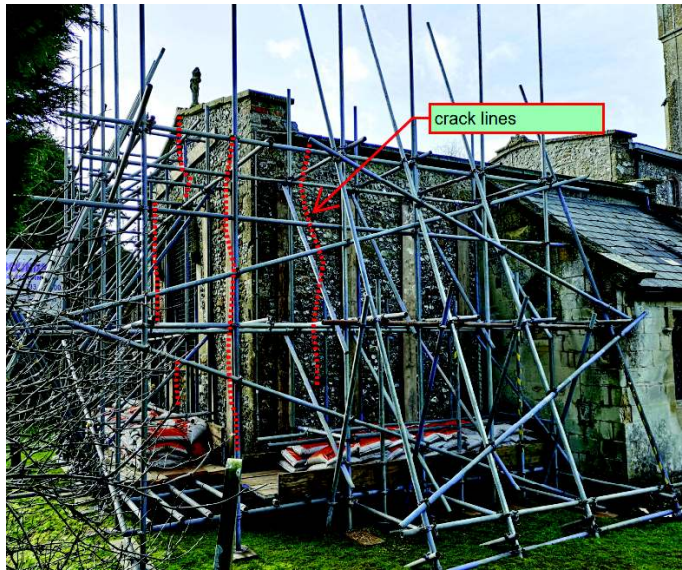
4.6 The external flint work appeared in places to be loose and the Church LPCC brought in a scaffold company to prop the chancel gable wall. The scaffold was installed in December 2018.

**Figure 4.4** : scaffold used to butress the walls as installed in December 2018; photo 16<sup>th</sup> March 2019 – highlighted for ease of understanding cracks noted on the walls externally.

9.2.6 The scaffold to the gable is not providing any current support other than stopping the north facing flint walling from bursting. The scaffold is in the way of remedial works and access, and with recommended internal propping and external flint panel work bracing should be removed. See technical note 4 for initial recommendations for temporary works.

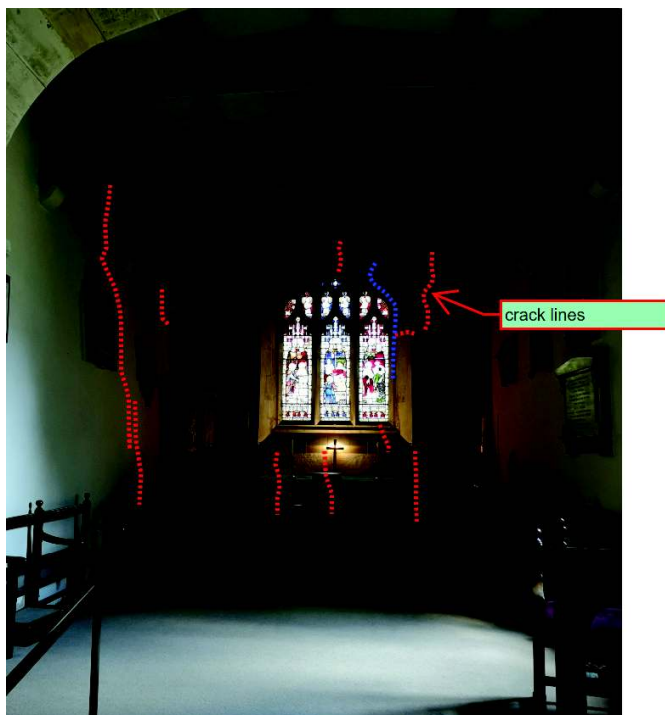
**Figure 4.5** : internal view of the chancel 16<sup>th</sup> March 2019 – highlighted for ease of understanding cracks noted on the walls internally.

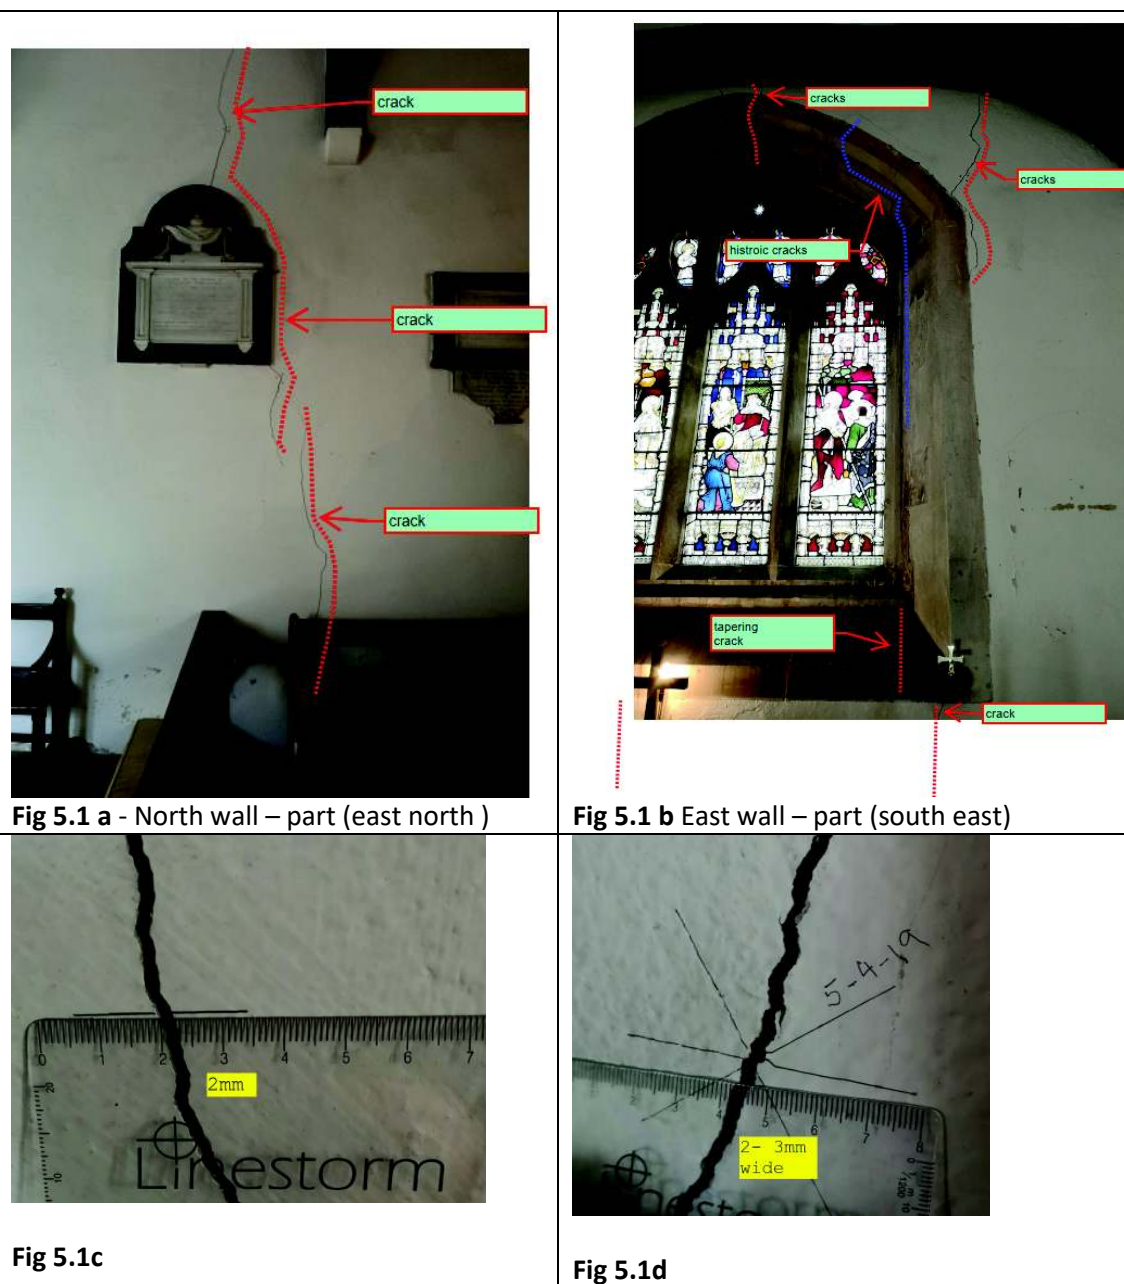
**Figure 5.1** – cracks noted in 5<sup>th</sup> April 2019 to the north wall and east gable wall- lower areas of cracks

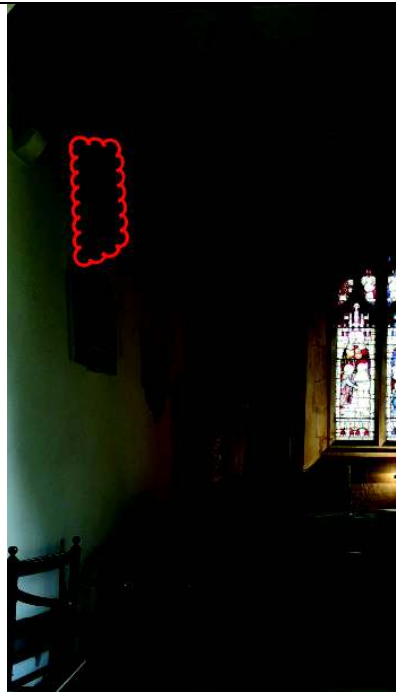
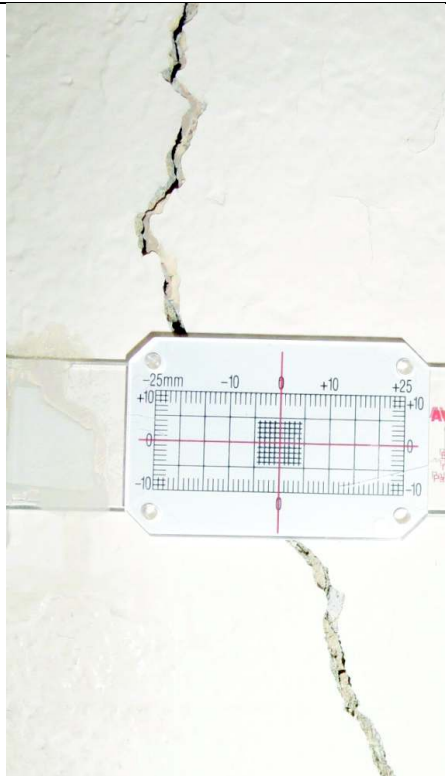
<p><b>Fig 5.2 a</b> Location of crack guage –north wall - installed 5 April 2019</p>	<p><b>Fig 5.2b</b> Guage and cracks around – 5<sup>th</sup> April 2019 – crack widths 1 – 2mm –</p>

**Figure 5.2** internal cracks as of 5<sup>th</sup> April 2019 as recorded by Milner Associates note that the render suggests bigger crack than is seen- this may be due to the opening and closing which the render is a true reflection of the movement.

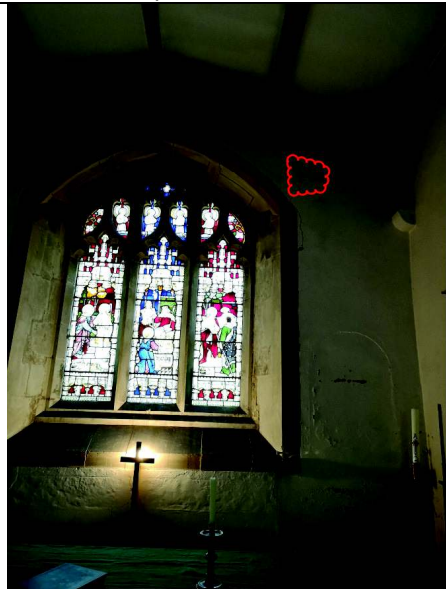
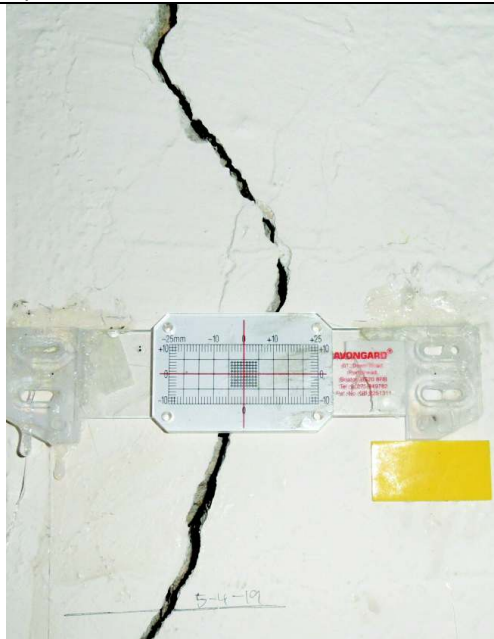
<p><b>Fig 5.2 c</b> Location of crack guage –east wall- installed 5 April 2019</p>	<p><b>Fig 5.2 d</b> Guage and cracks around – 5<sup>th</sup> April 2019 – crack widths 3 to 6 m on the render but not taper back to the crack in the wall itself.</p>

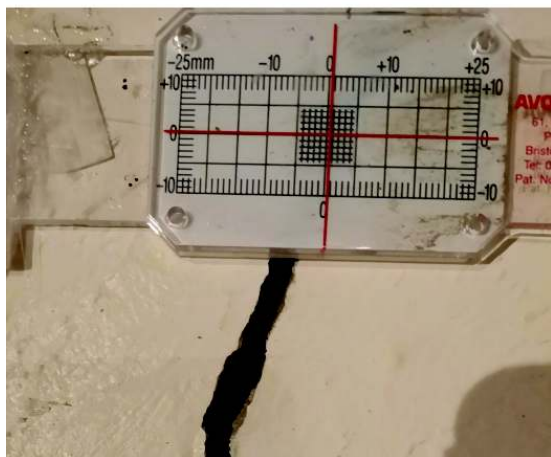
**Figure 5.3** internal cracks as of 8<sup>th</sup> August movement noted approx. 0.8mm opening – at the east gable wall.

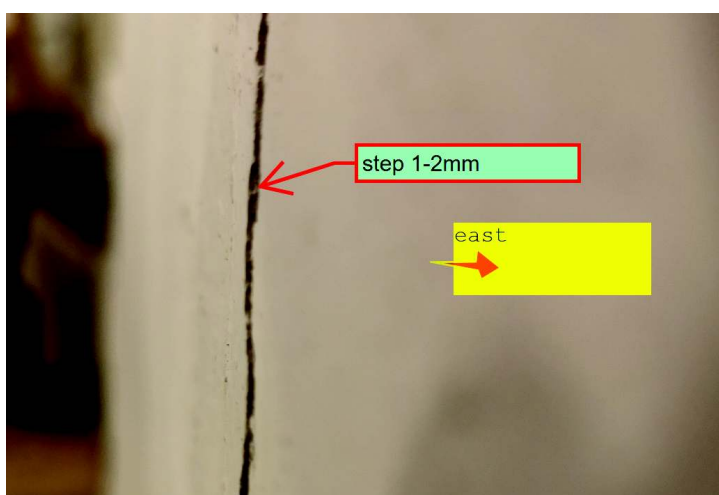
**Figure 5.4** internal cracks as of 8<sup>th</sup> August movement noted approx. 0.5mm step rather than increase in width – at the north wall.

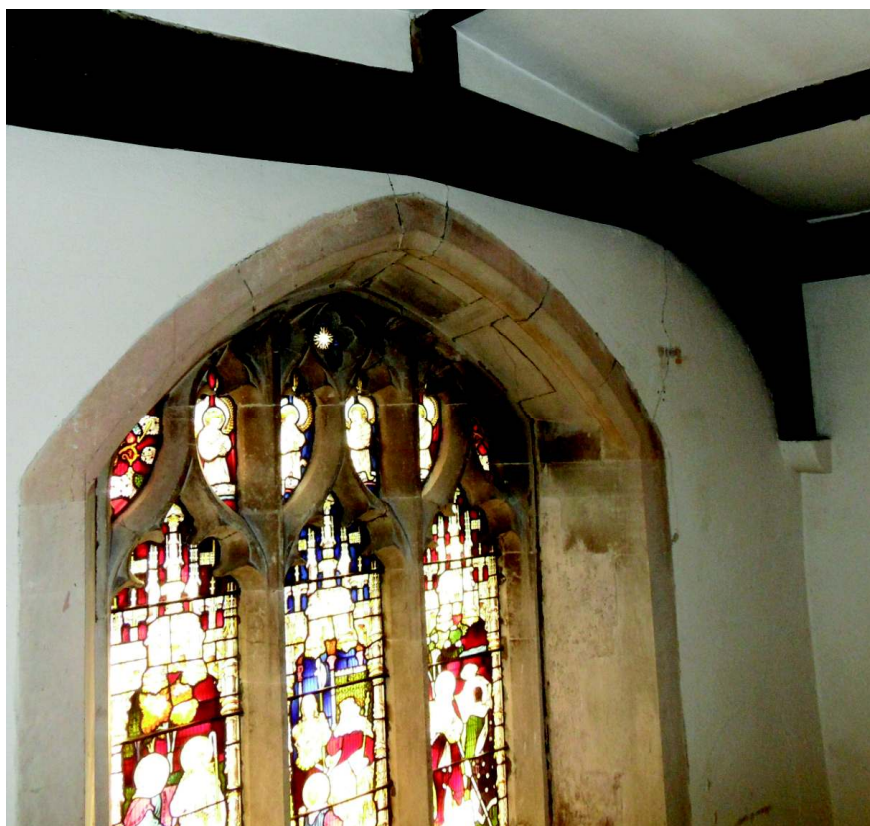
**Figure 5.5** gable wall and east window as of 5<sup>th</sup> April 2019 - Note darker pointing around the stone window frame which suggests historic repairs. There are signs of new movement and in particular the key stone at the top of the window.

9.2.5 Without intervention within the next 18 months there may be damage to the stain glass and onward distress to the stone work.

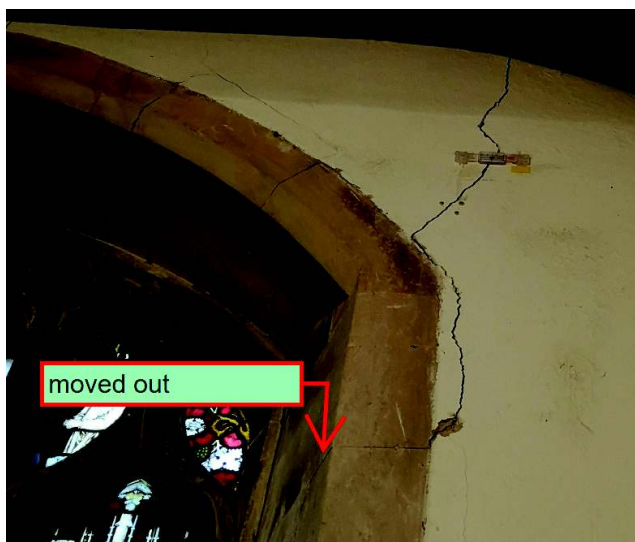
**Figure 5.6** gable wall and east window as of 8<sup>th</sup> August 2019 - Signs of new movement and in particular stone rotation.

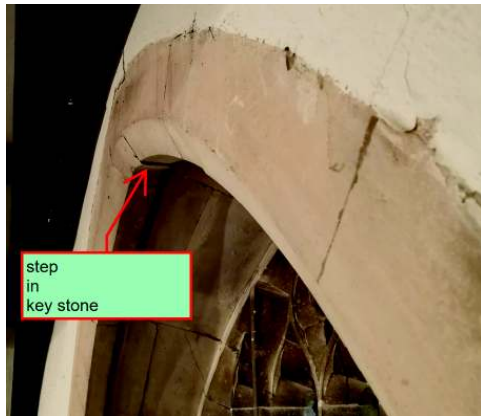
**Figure5.7** gable wall and east window as of 8<sup>th</sup> August 2019 - Signs of new movement and in particularly stone step.

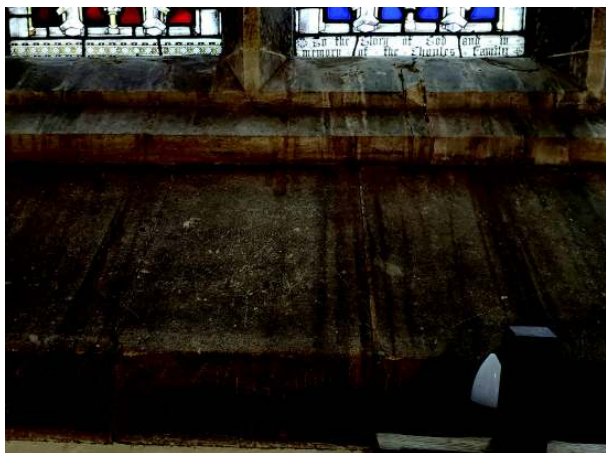
**Figure 5.8** gable wall and east window cill as of 5<sup>th</sup> April 2019 - Signs of movement in stone cill; some recent some historic.

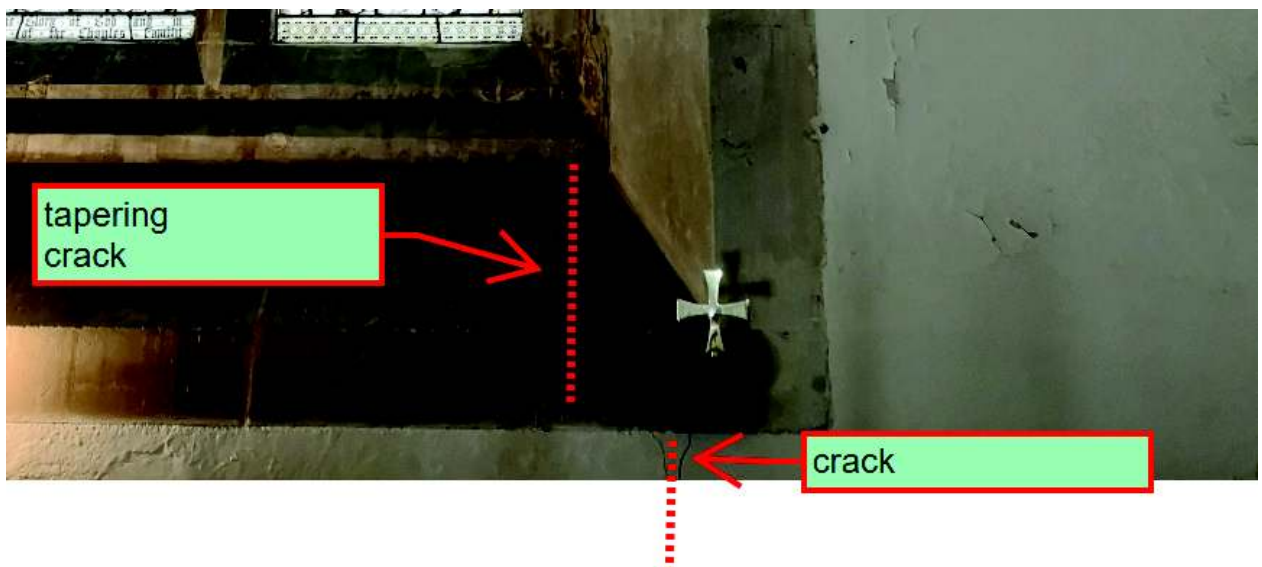
**Figure 5.9** gable wall and east window south side as of 8<sup>th</sup> August 2019 - Signs of new movement and in particular stone cill rotation.

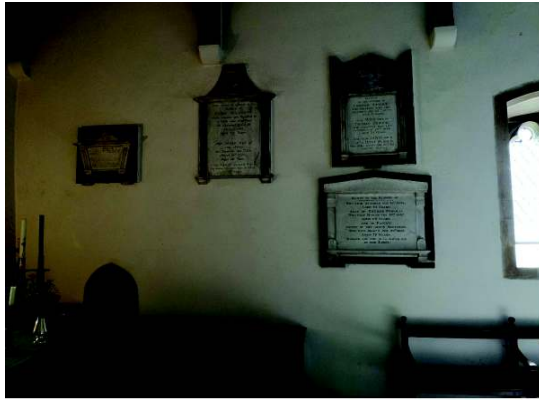
**Figure 5.10** south wall as of 8<sup>th</sup> August 2019 – No Signs of movement

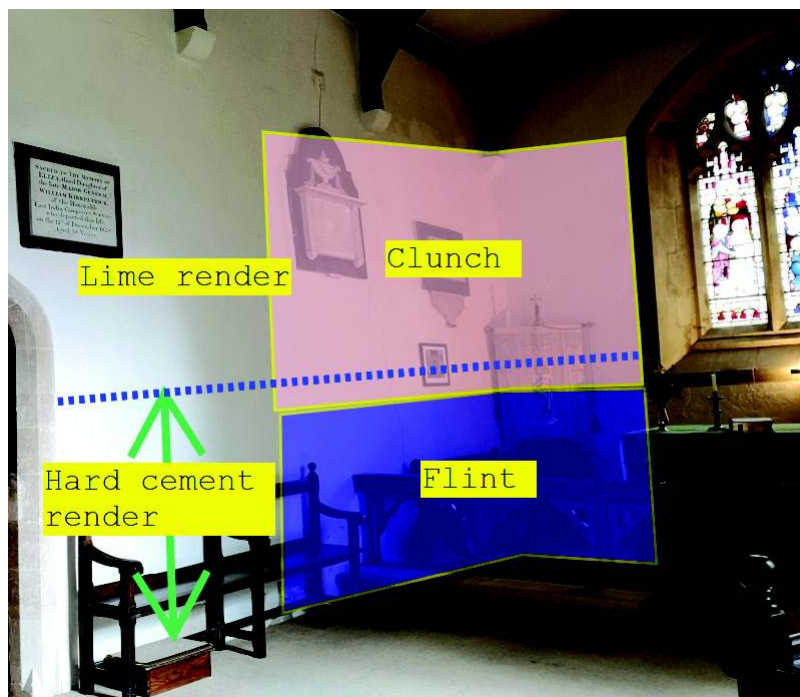
**Figure 5.11**– findings of the wall make up in the chancel north east wall corner .

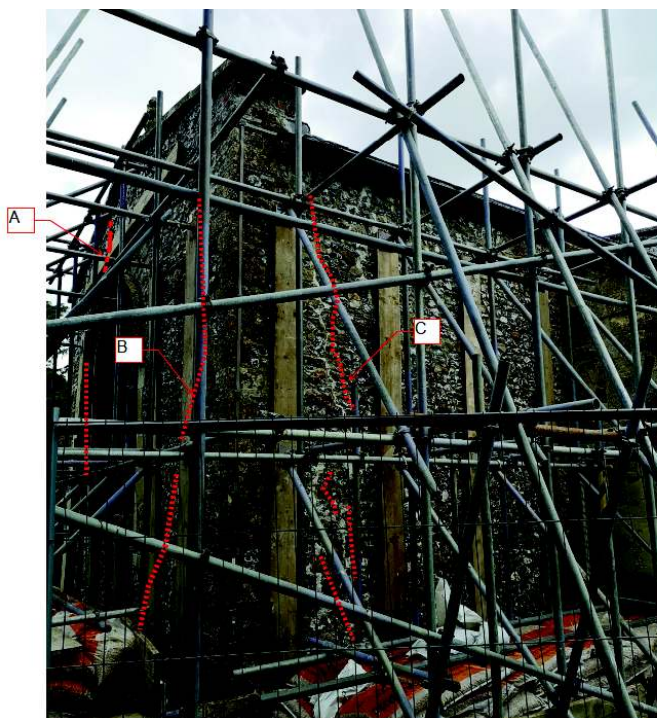
**Figure 6.1** view of the North east corner with marked areas of the significant cracks in the flint work.

6.1 At the instruction of Milner Associates in May 2019 temporary lime putty mortar was installed into the significant cracks to stop the loose dry lime and sand fill from migrating out of the cracks. In addition flints were loose and progressive failure would have occurred without intervention.

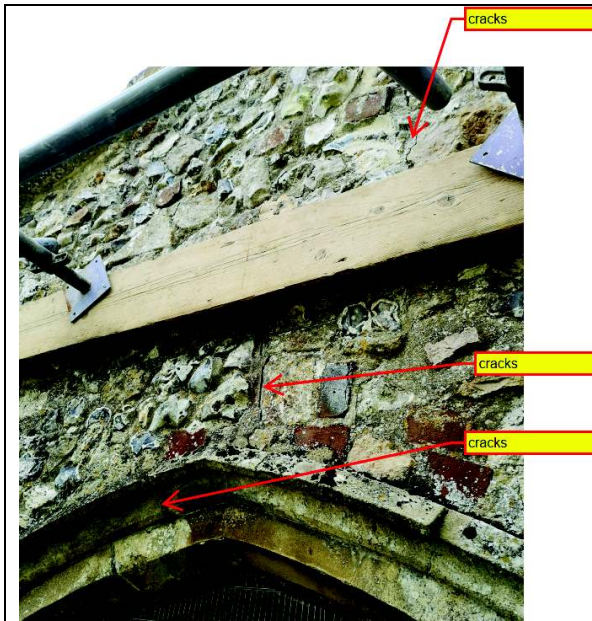
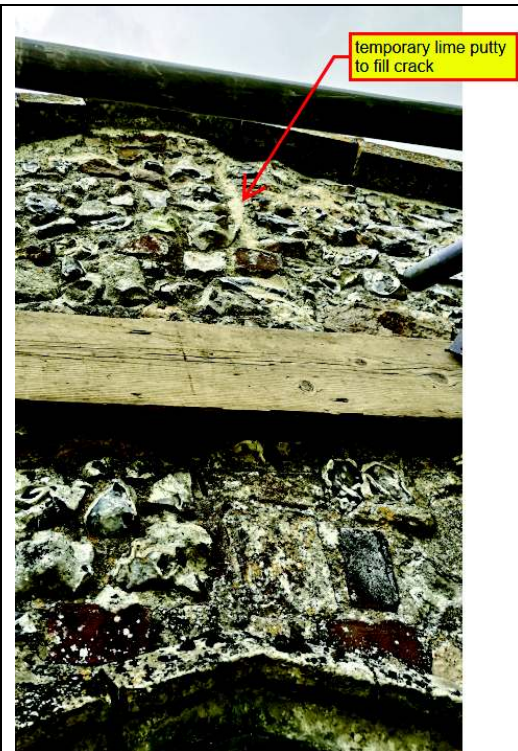
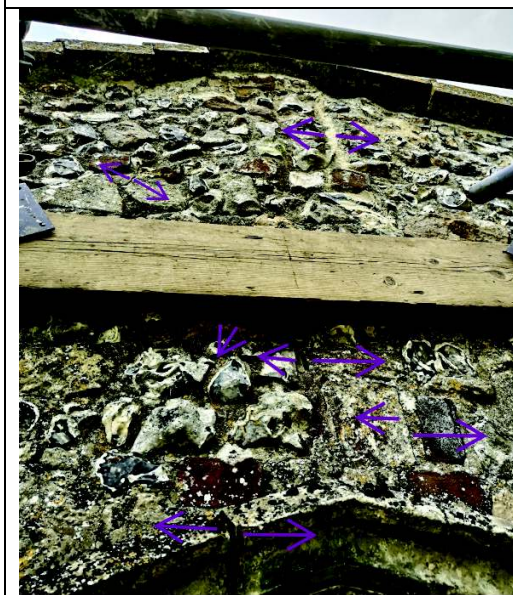
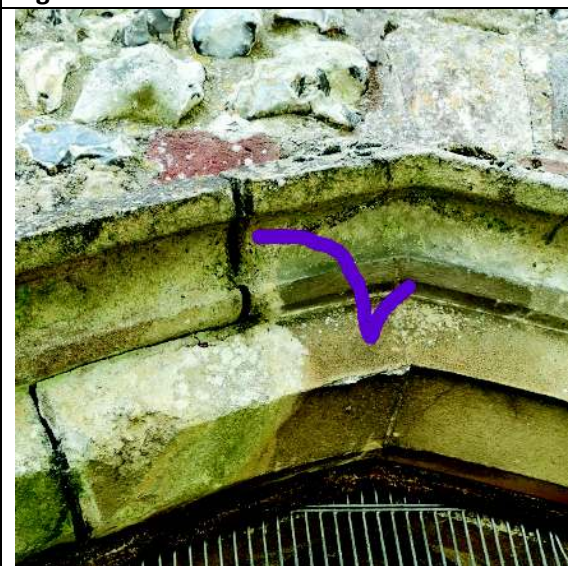
**Figure 6.2 – East gable cracks above window highlighted** - crack widths vary from 2 to 5 mm. Loose failed mortar opened up cracks to suggest larger crack widths.

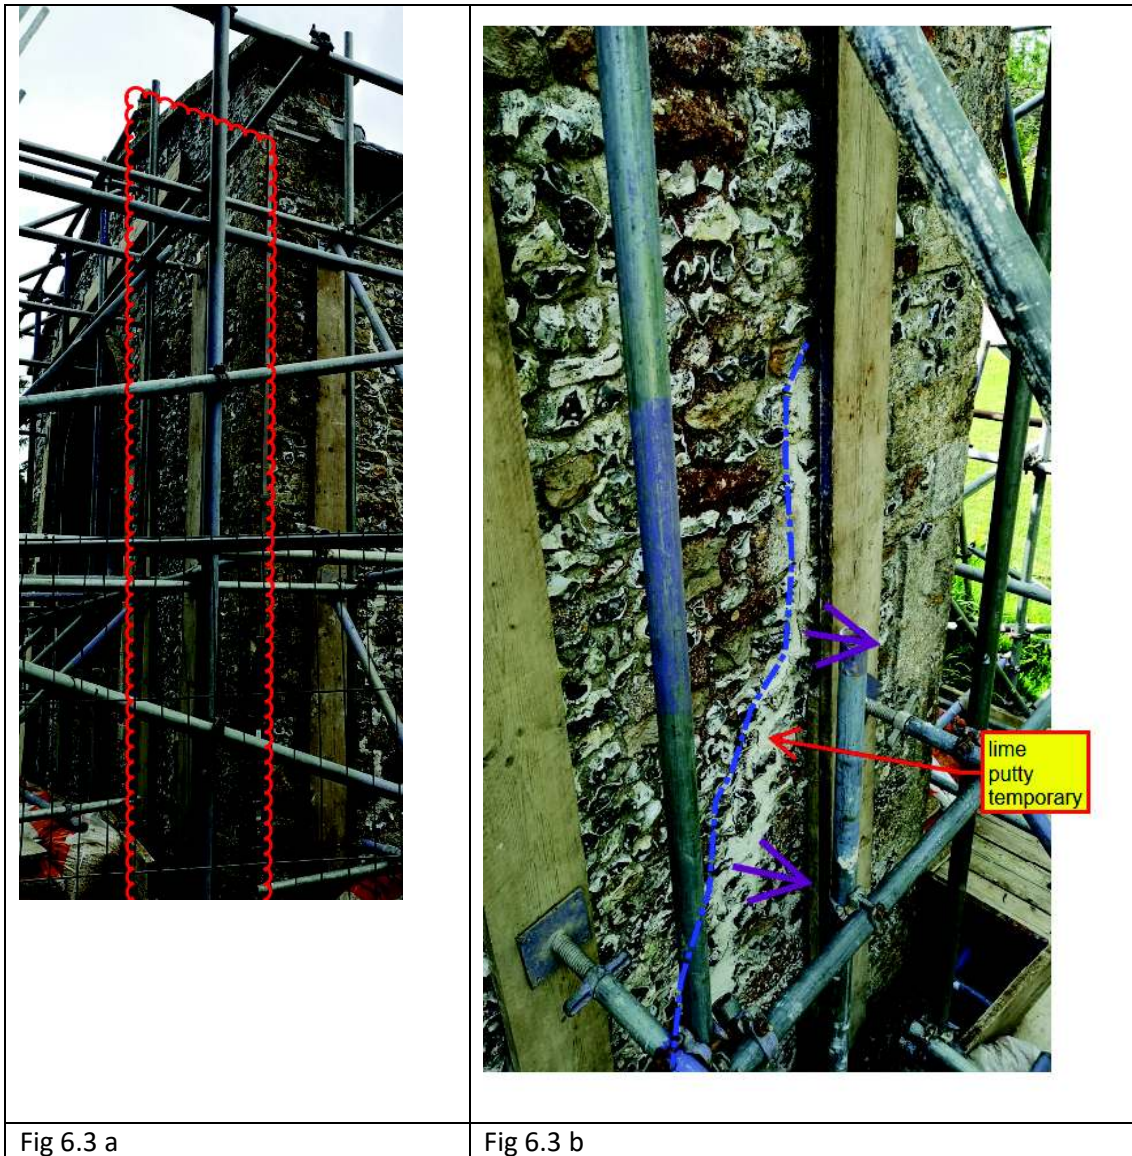
**Figure 6.3 – North East corner east wall gable** - crack widths vary from 2 to 10 mm. Loose failed mortar opened up cracks to suggest larger crack widths.

6.4 At the instruction of Milner Associates in May 2019 temporary lime putty mortar was installed into the significant cracks to stop the loose dry lime and sand fill from migrating out of the cracks. In addition flints were loose and progressive failure would have occurred without intervention.

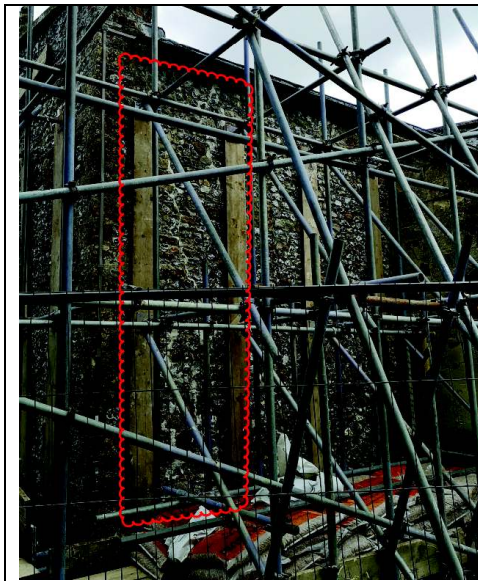
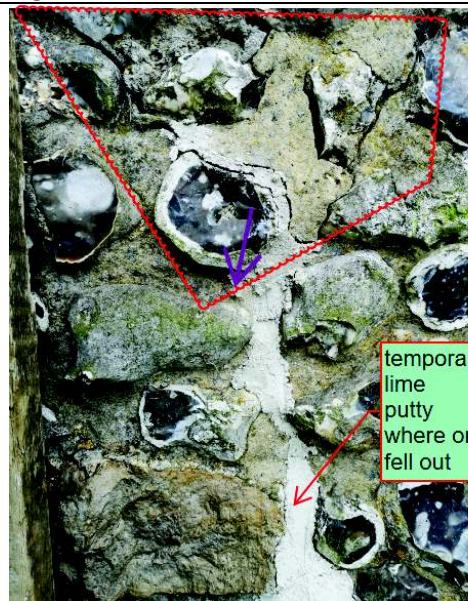
**Figure 22 – East gable cracks highlighted** - crack widths vary from 2 to 10 mm. Loose failed mortar opened up cracks to suggest larger crack widths.

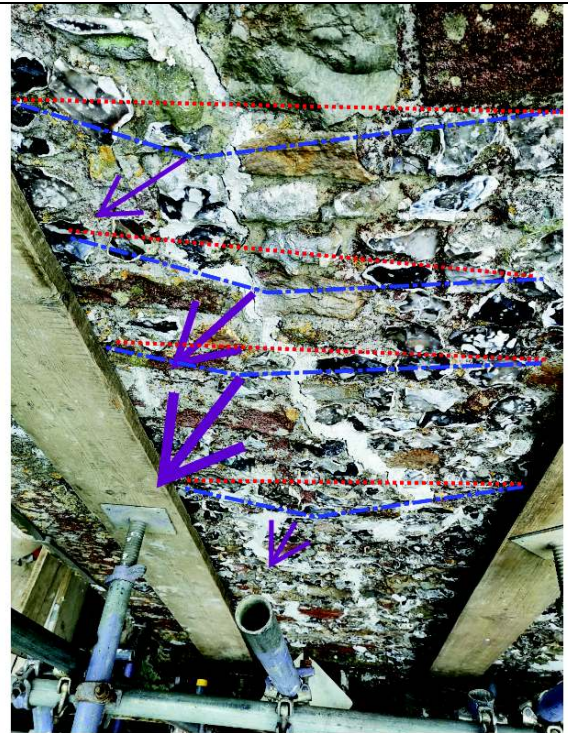
Fig 6.4 c – bow outwards 20 to 40mm

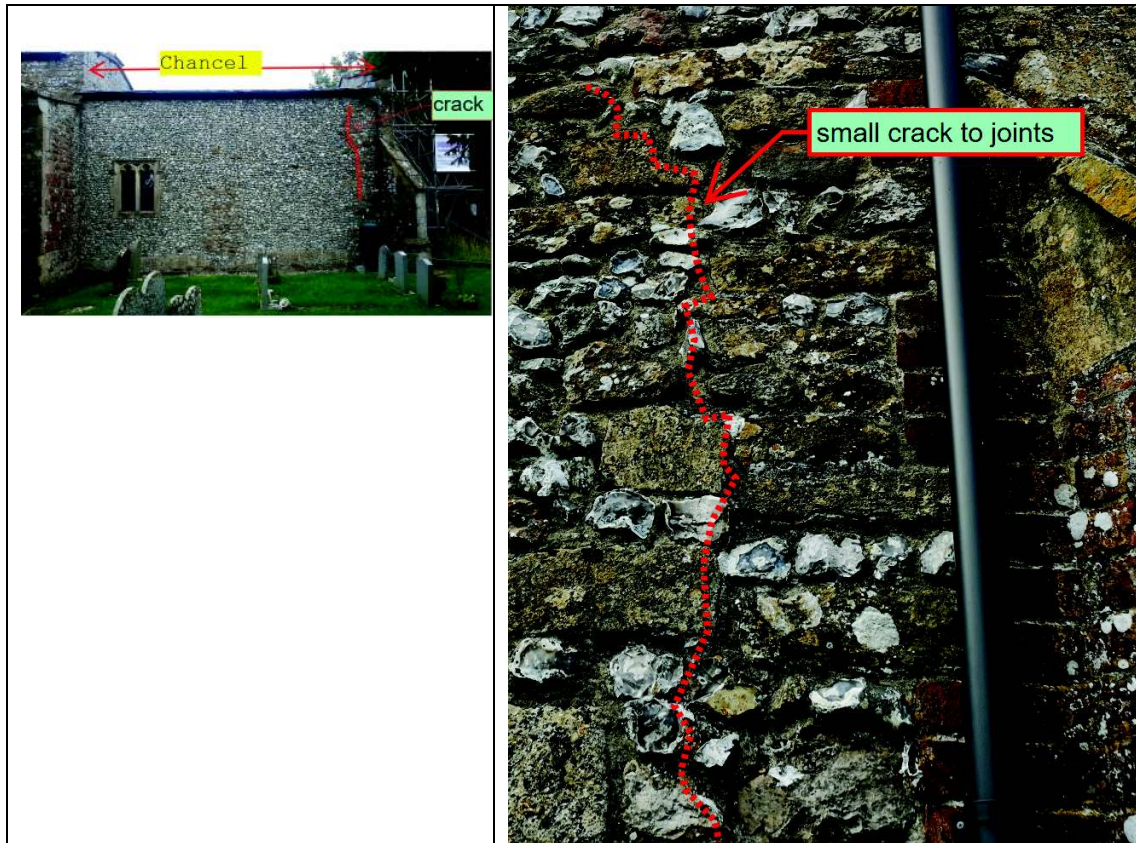
**Figure 6.5** – south wall externally (photo August 2019) showing crack (1-2mm) noted during April 2019 visit.

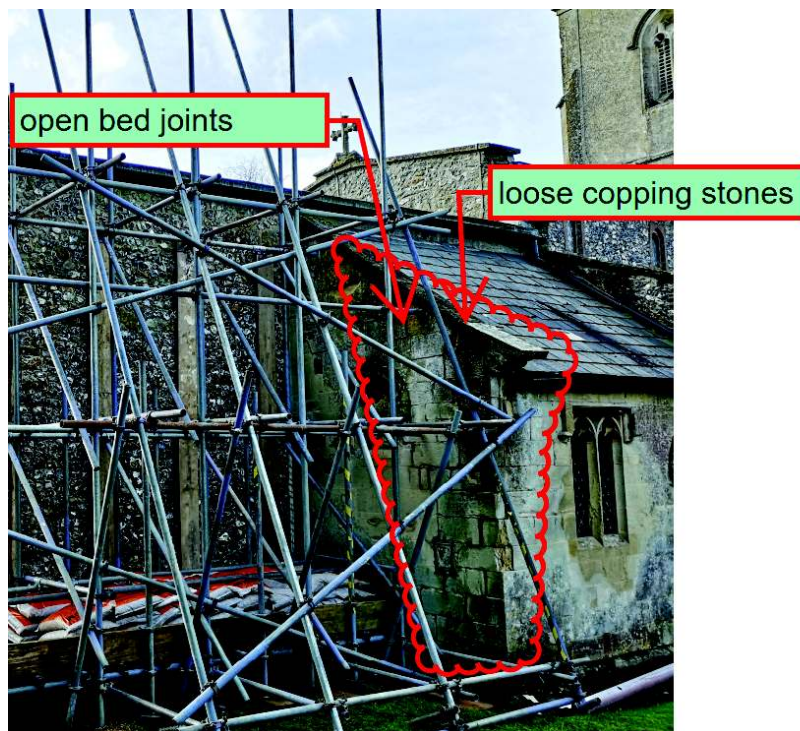
**Figure 6.6** – Vestry wall externally (photo August 2019) showing cracks loose coping stones.

9.2.8 The vestry to the side of the north wall of the chancel, built in mid nineteenth century is on shallow foundations on to clay that is subjected to seasonal movement. The up and down movement of the outer north east corner has caused the east gable verge stone work to become loose and needs repair. As the roof connects to the verge stone work water ingress at this junction is inevitable and progressive decay of the building fabric in this area will occur.

9.2.9 The need for underpinning is still to be considered as it has survived adequately without this need but the rebuilding of the stone work to the roof verge line is needed with tying back to reinforce it. Initial remedial works will be developed further in Milner Associates Technical note 4.

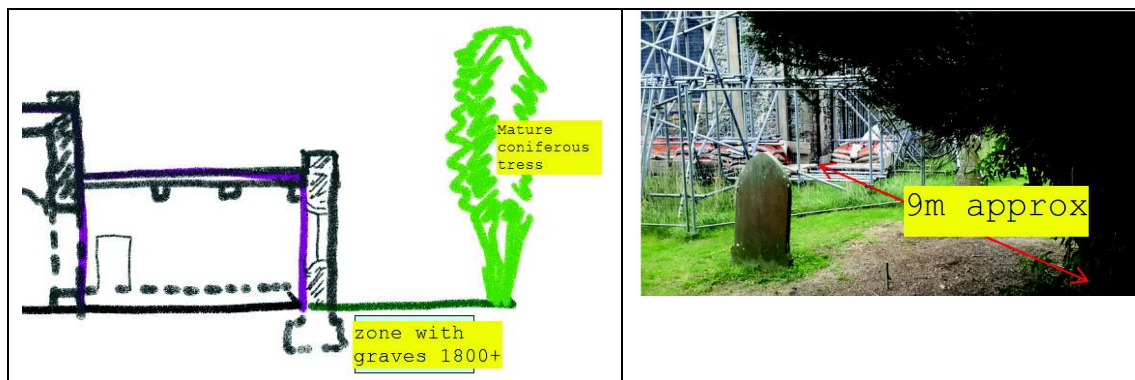
**Figure 7.1** – externally there are mature trees within 9 m of the chancel. The ground as noted from the walk over inspections shows the ground to be uneven but this may be due to the graves collapsing over time. Note that there are deciduous trees in the neighbours gardens.

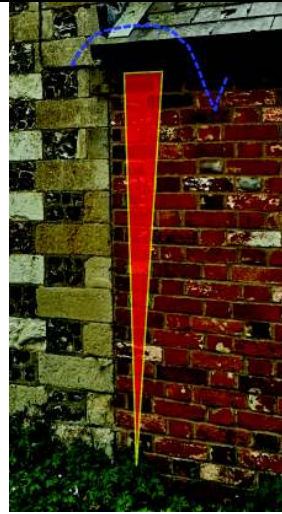
Fig 8.1 – signs of foundation movement on building next to church

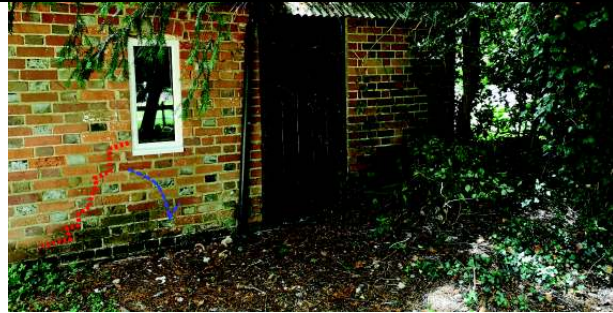
Fig 8.2 – signs of foundation movement on building next to church

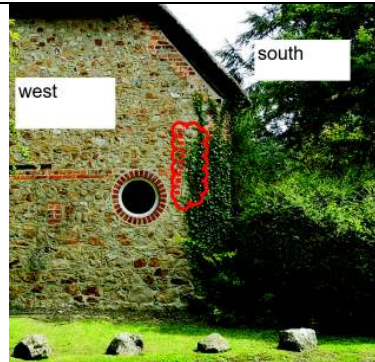
Fig 8.3 – signs of thermal cracking on new hard clunch building near by the church

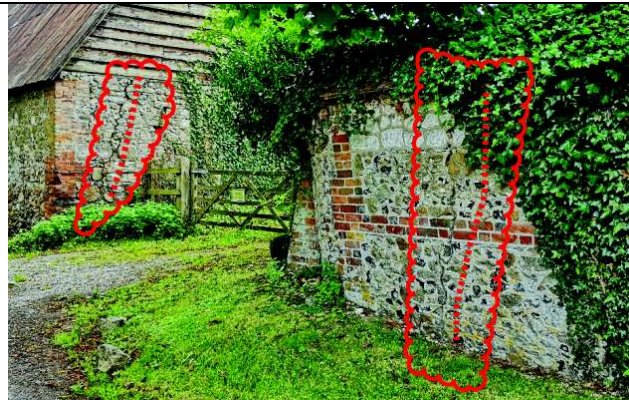
Fig 8.4 – signs of foundation movement and thermal movements on clunch and flint walls near to the church
